# **EXHIBIT 111**

Transmitted by the expert from Korea

# Defect Investigation on Panoramic Sunroof in KOREA

May 2014

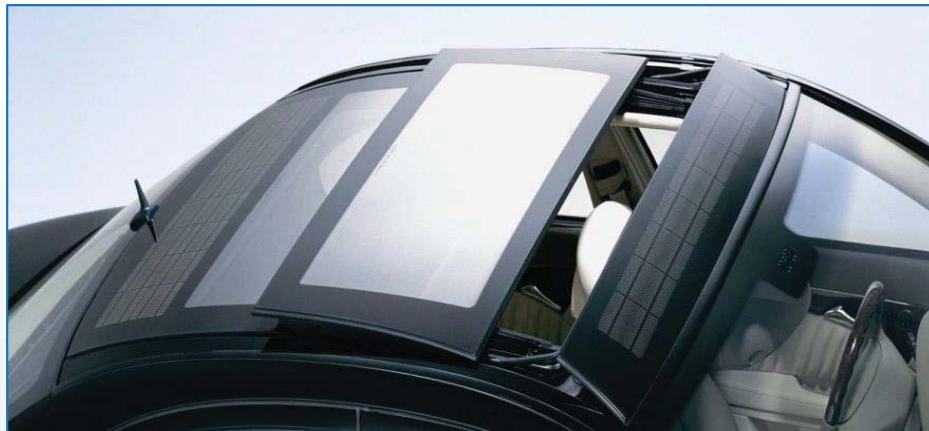
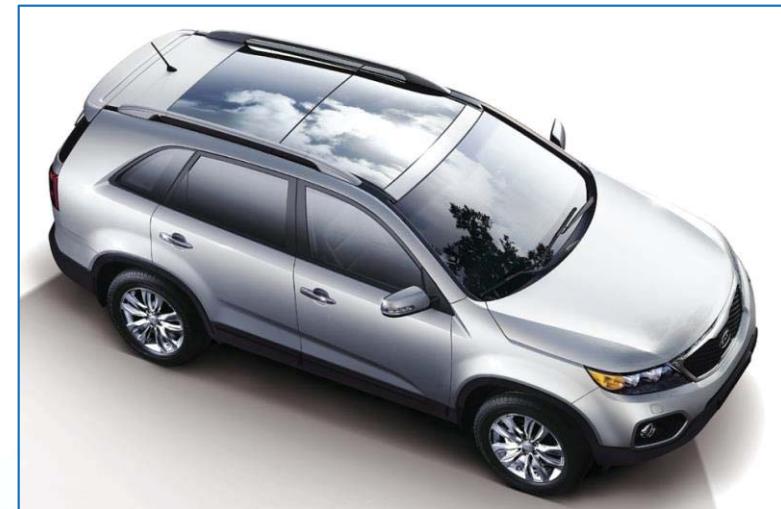
- Sharp increase in consumer complaints of panoramic sunroof.
  - 2011 : 2 cases
  - 2013 : 33 cases (5 cases of imported models)
- Details of consumer complaints.
  - Sudden shattering of panoramic sunroof while driving the car with the driver unaware.
  - Driver may suffer abrasions due to shattered glass and encounter risk of secondary accidents.

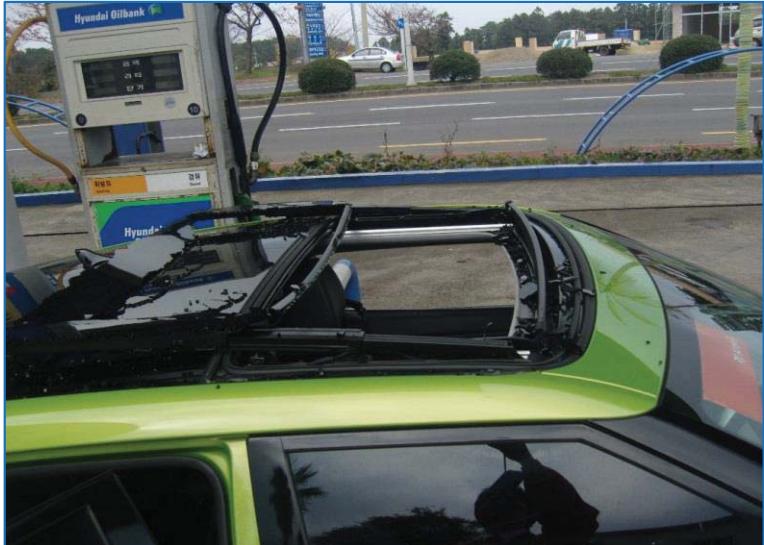
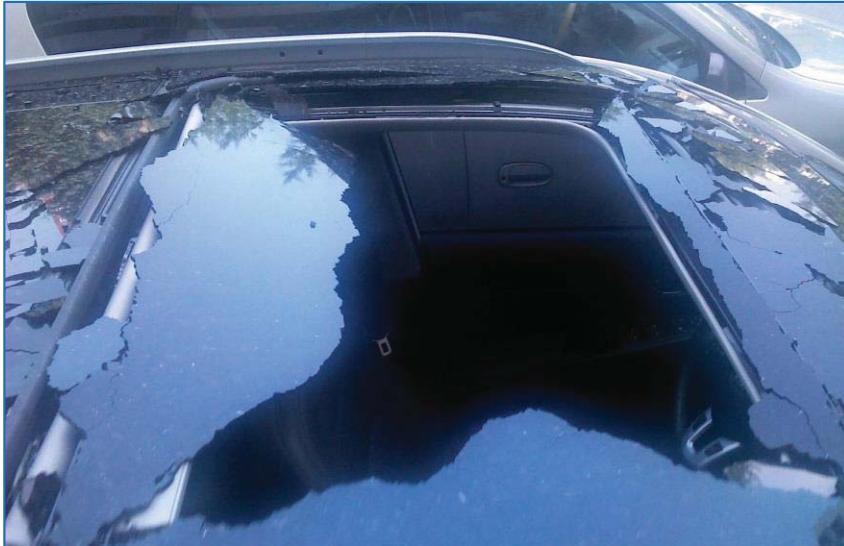
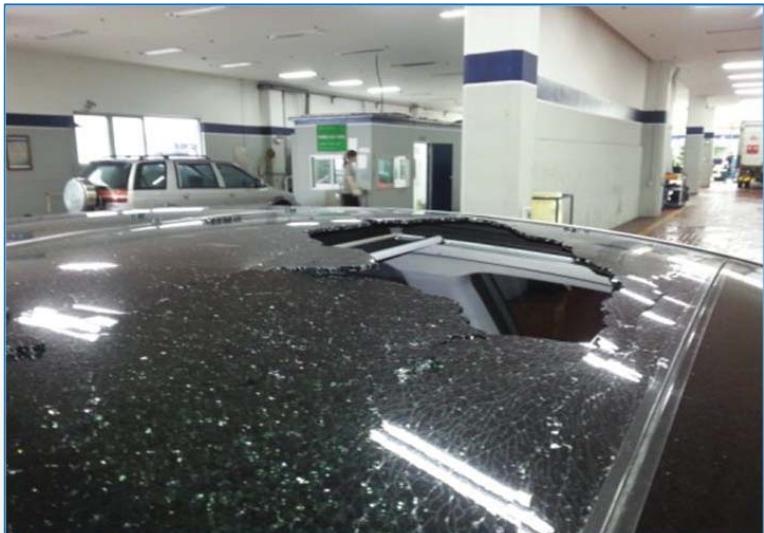
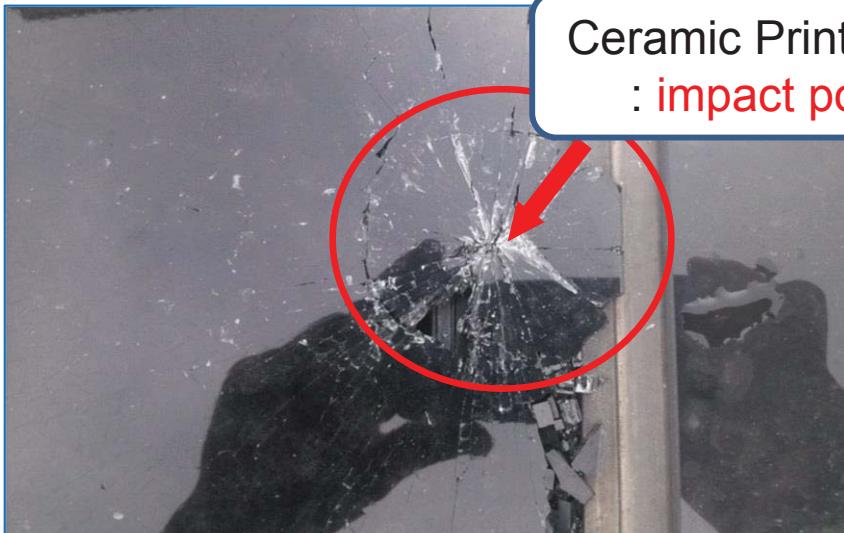
### Images of panoramic sunroof damages(1)

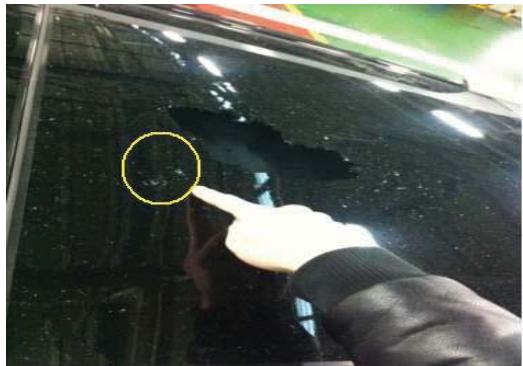
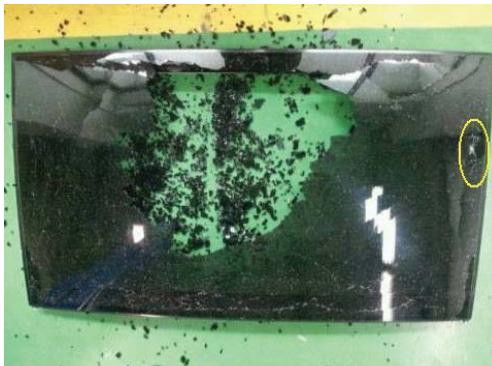
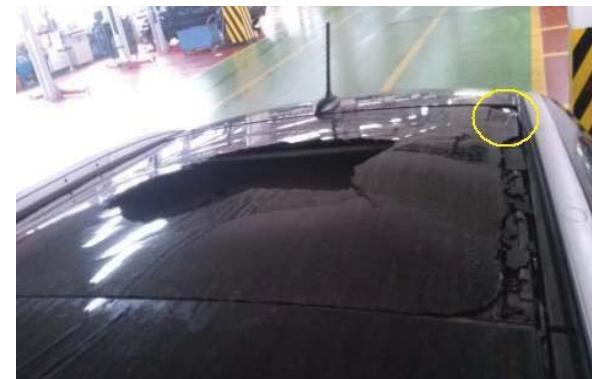
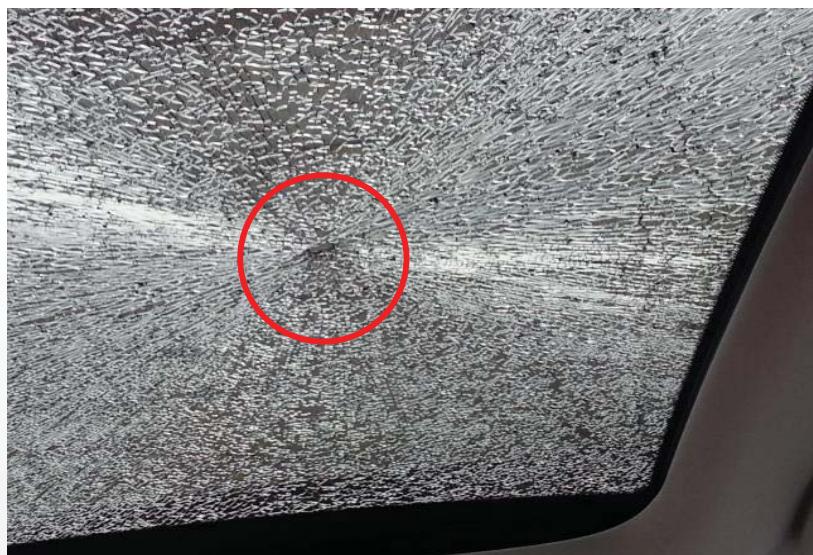
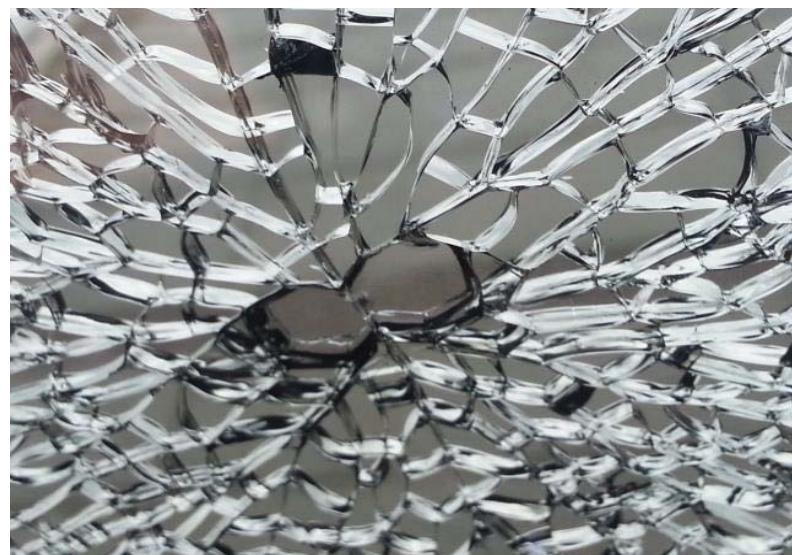
### Images of panoramic sunroof damages(2)
